**The Appraisal and Management of
Multi-storey Dwelling Blocks Using Large Concrete
Panel Systems**

AMMAR YOUSUF THANNON
Doctor of Philosophy

THE UNIVERSITY OF ASTON IN BIRMINGHAM
June 1989

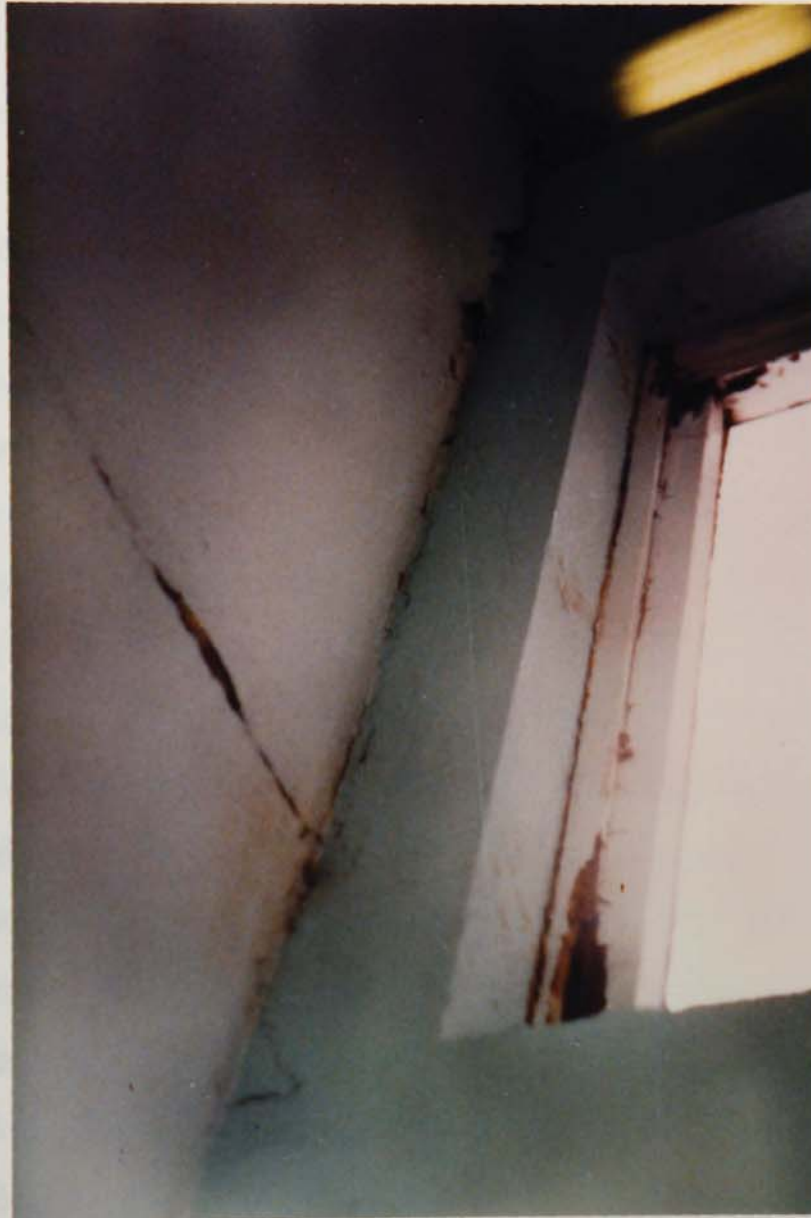
In general, serious structural deterioration has not found in these case studies so far, which means that there were no obvious sign of structural distress.

Plate 5-1 Structural connection and external fixture defects

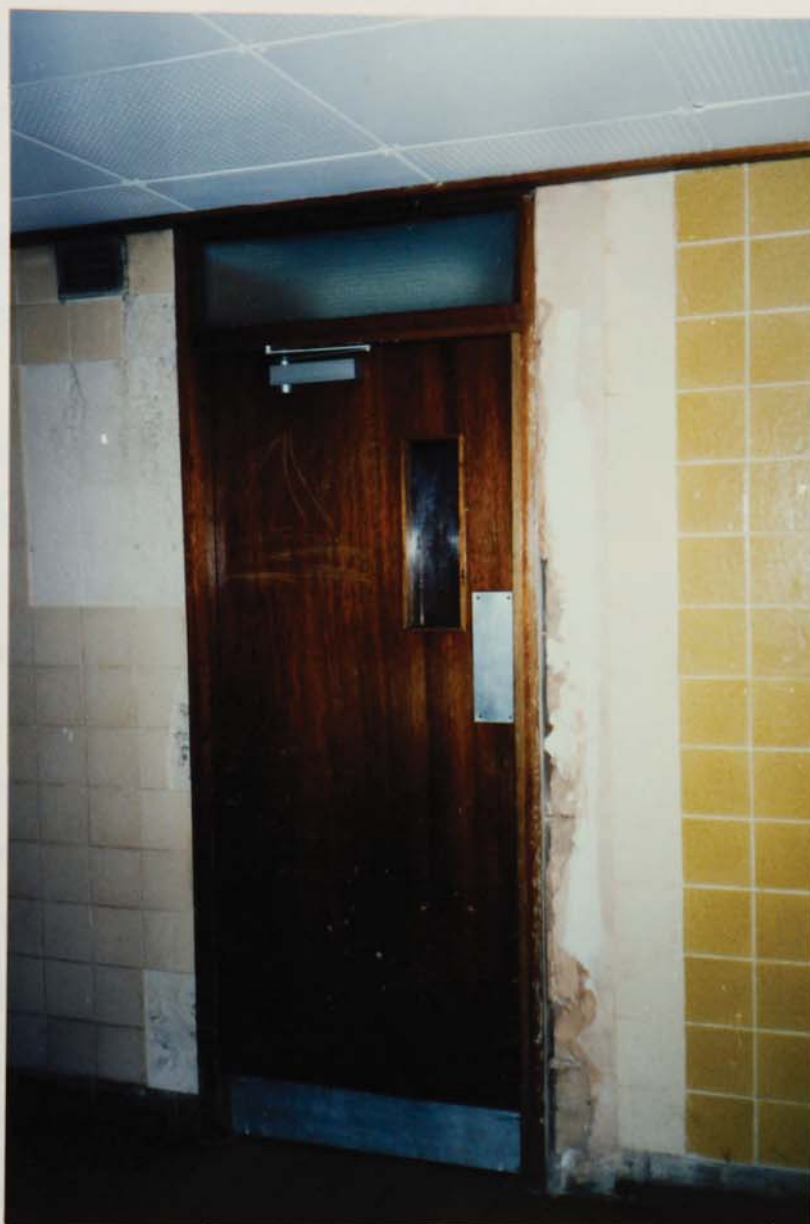
Plate 8-1 The damaged back door in the Normansell Tower

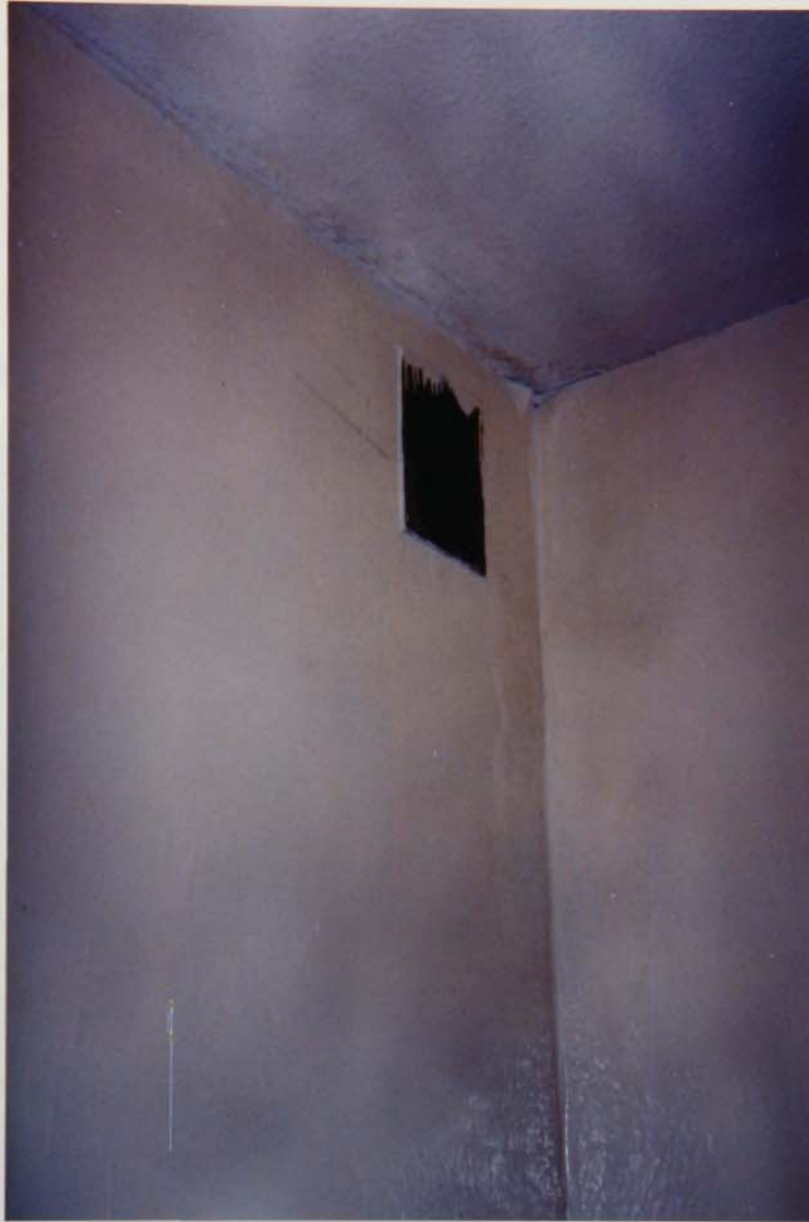
The most significant physical and social defects in Stokesay House were the insulation (71% of the respondents dissatisfied), ventilation (around 60% of the respondents dissatisfied and as shown in plate 8-2, there were many ventilation openings have been covered by a layer of mould), front and rear main doors of the block, communal areas (less than 25% were satisfied), the main security system (89% of the respondents dissatisfied, most of them strongly dissatisfied), the central heating system (around 50% dissatisfied with 41% not using the central heating system in the dwelling), the lifts (less than 50 % were satisfied), the safety (i.e. the lack of a feeling of security), the vandalism and childrens' play facilities.

Plate 8-2 Mould layer covered the ventilation duct openings in the Stokesay House roof

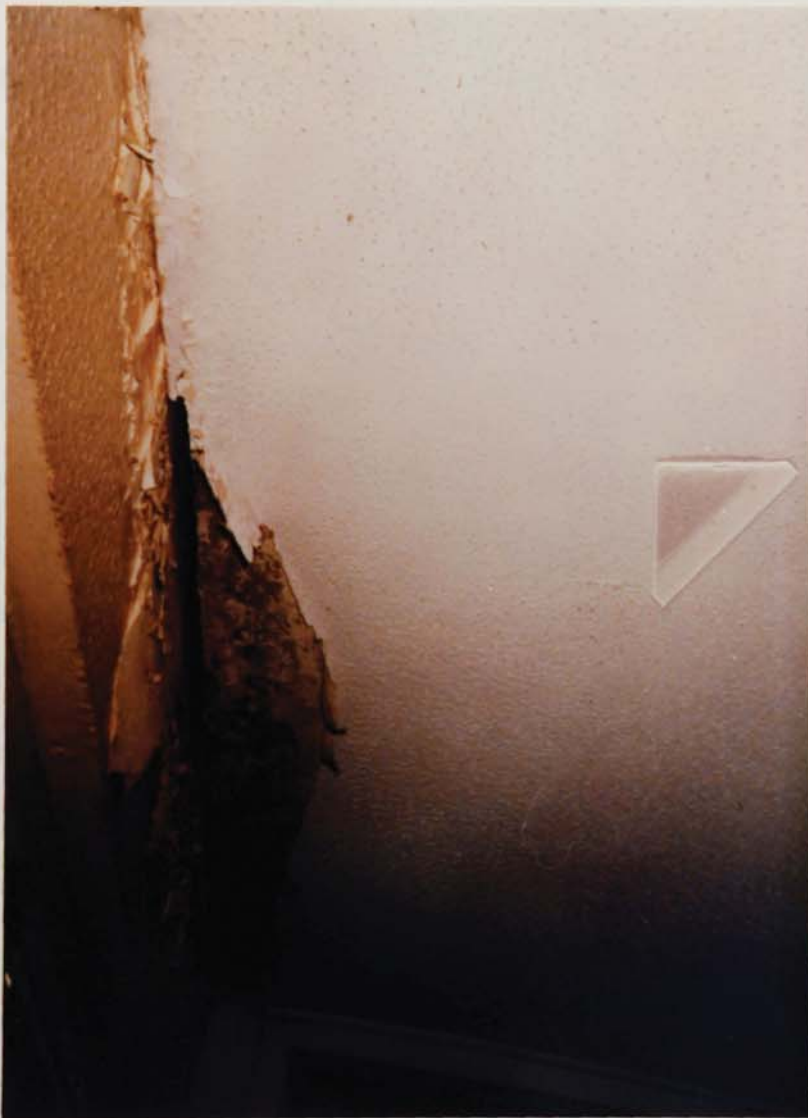
The physical appraisal survey indicated that Lapworth House was structurally good with no evidence of existing structural failure. It seemed to be in poorer structural condition than the above two blocks. The external load bearing panels showed some evidence of distress. This could be seen throughout the block with cracking at the panel intersections, the worst cases being at the joint between floor units and external load bearing panels, see plate 8-3. This constitutes not only a potential structural risk but also allows a path for the spread of smoke and flame in

Plate 8-3 The joint between floor units and external load bearing panels Lapworth House.

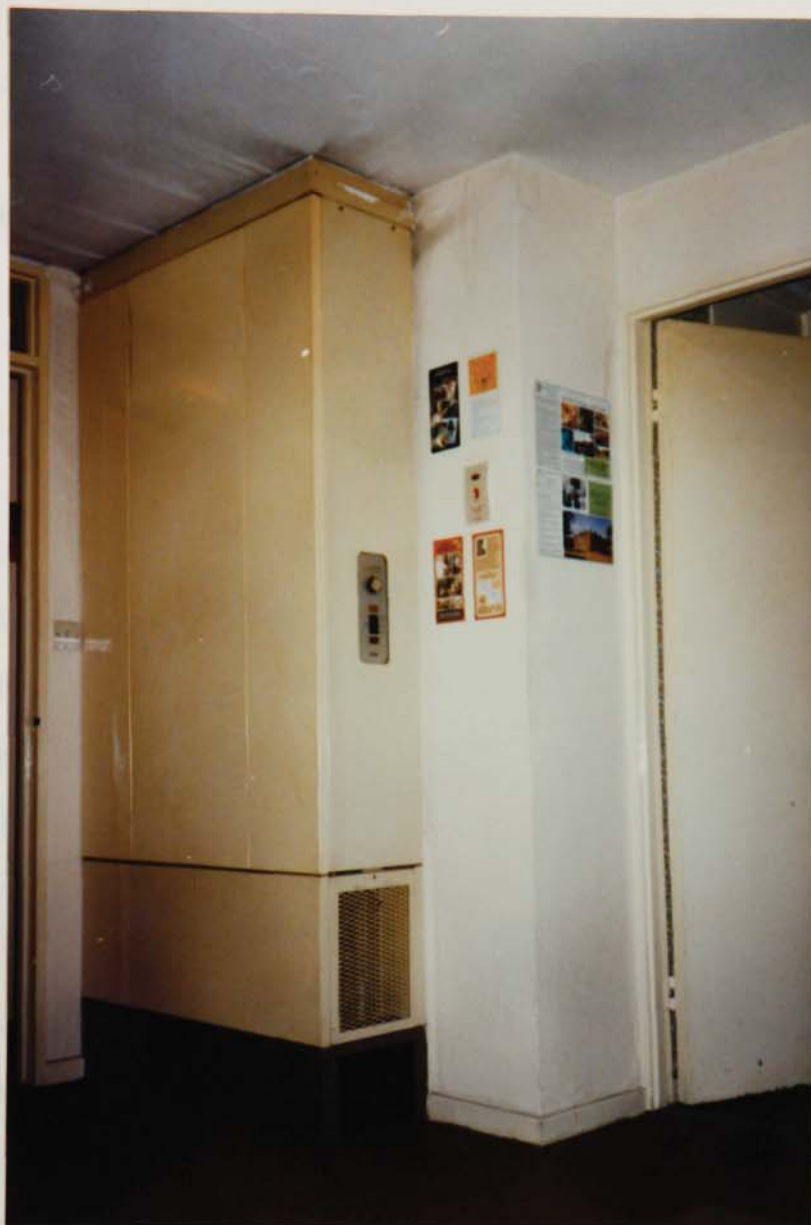
Plate 8-4 The inefficiency of the central heating system in the Dorset Tower block

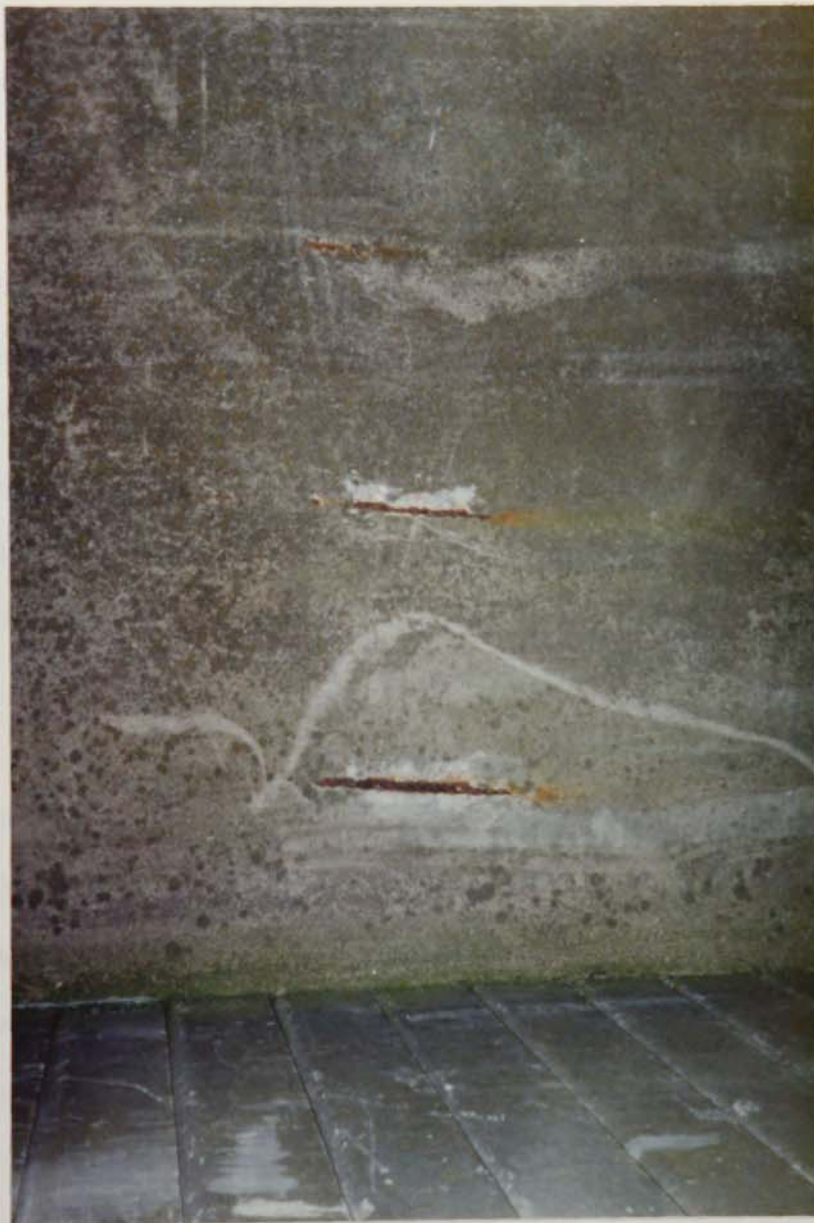
The physical appraisal survey indicated that the Woburn House was structurally good with no evidence of existing structural failure. In the finishes category, the CAN UK report highlights problem areas as being both hairline cracking of the panels and many areas of re-bar exposed. The technical report showed some of the concrete panels needing attention (due to corrosion of the ties between the inner

Plate 8-5 Exposed reinforcement bar in the parapet of Woburn House

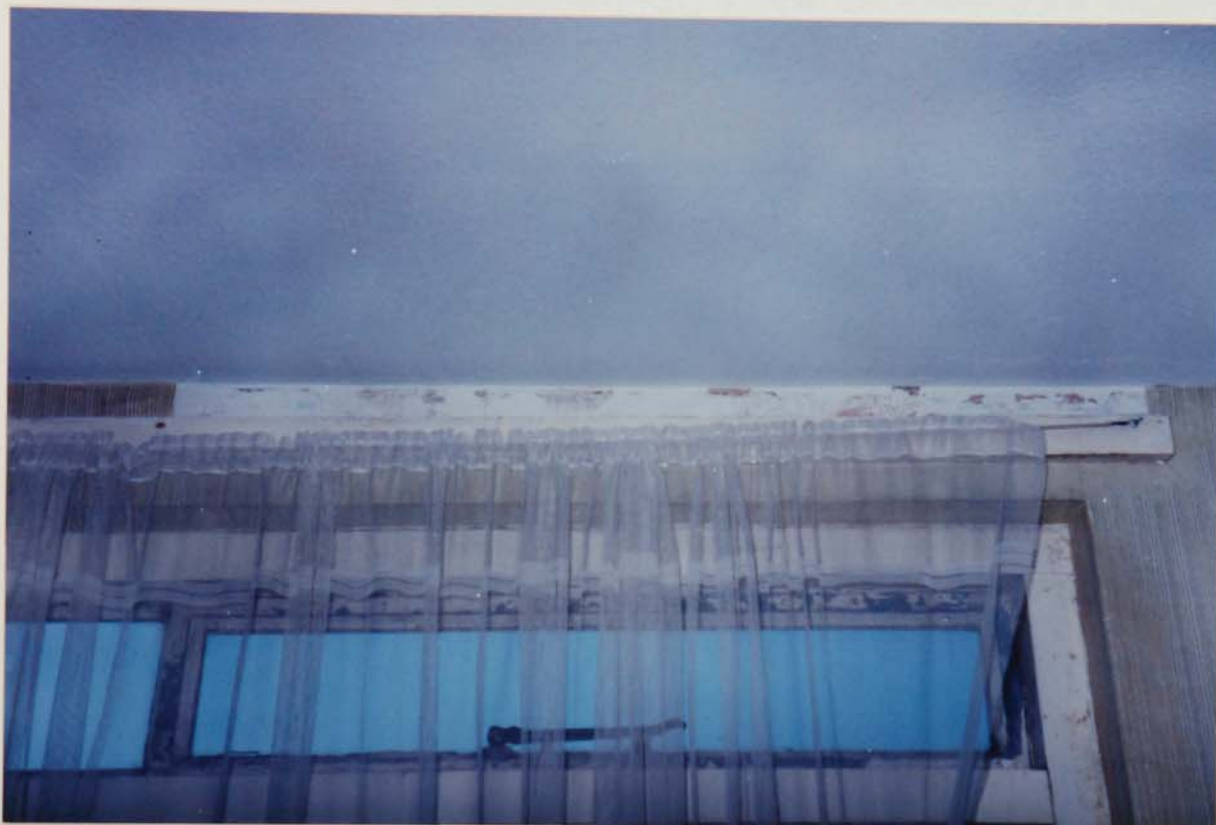
Plate 8-6 The dwelling damp evidence in Weston House block

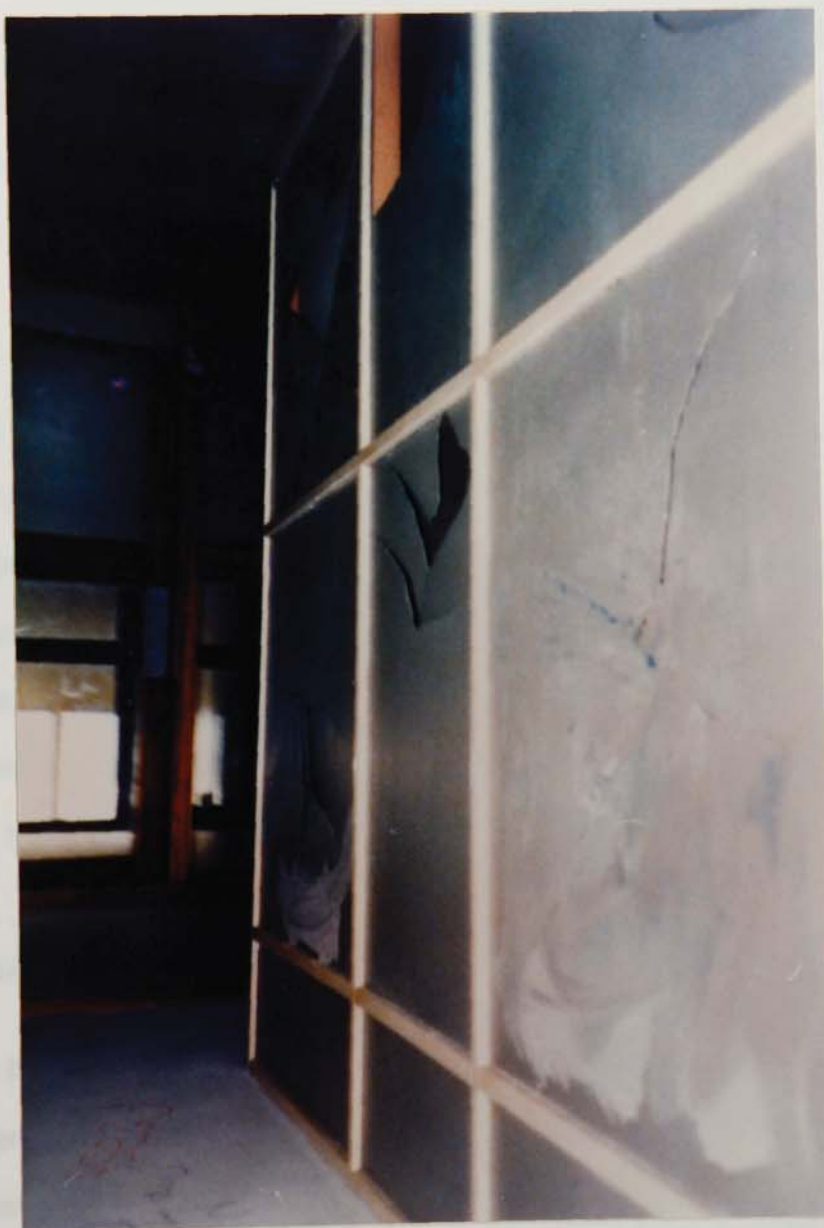
Plate 8-8 The damaged partitions in Netley House block
