**The Appraisal and Management of
Multi-storey Dwelling Blocks Using Large Concrete
Panel Systems**

AMMAR YOUSUF THANNON
Doctor of Philosophy

THE UNIVERSITY OF ASTON IN BIRMINGHAM
June 1989

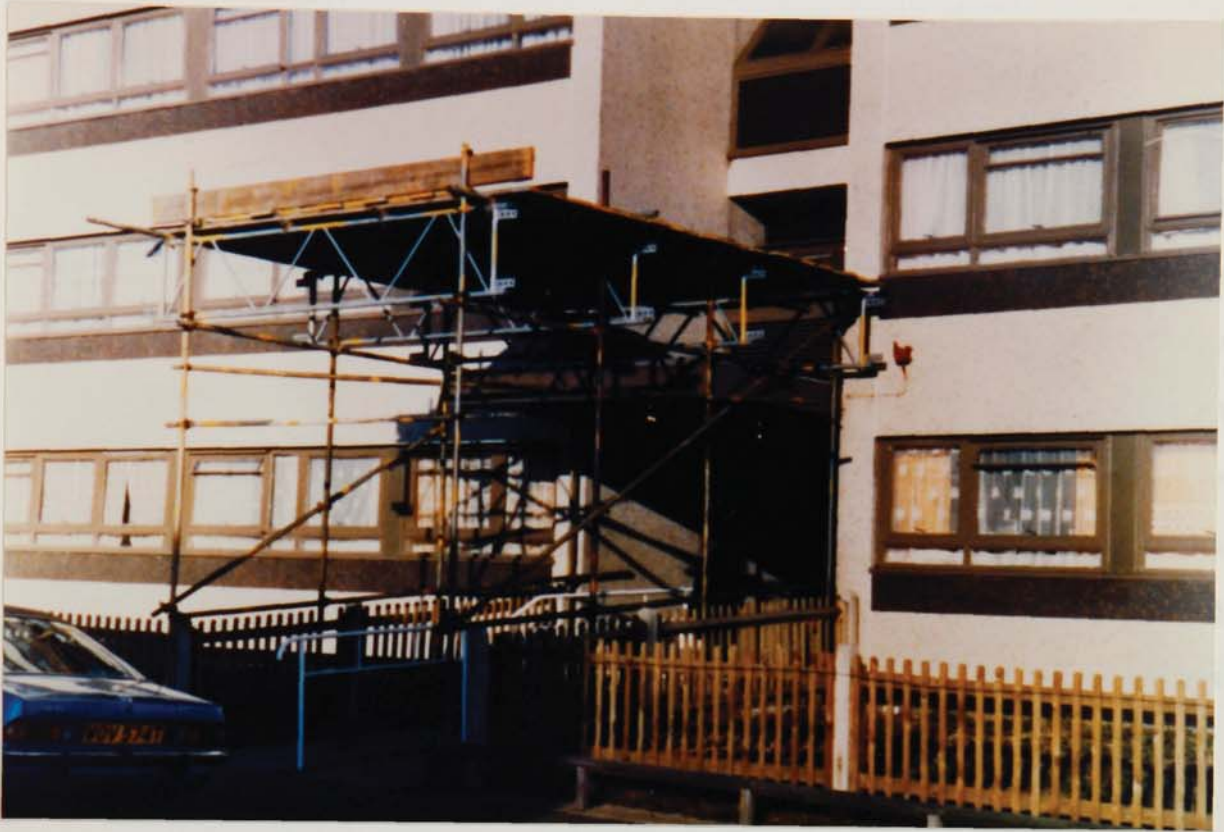
Plate 8-7 The scaffold to the main entrance of the Barry Jackson Tower

Department has been forced to erect scaffold around the bottom of the block as a safety precaution, as shown in plate 8-7. The technical report showed some of the concrete panels needing attention (due to corrosion of the ties between the inner and outer leaves of the exterior panels).

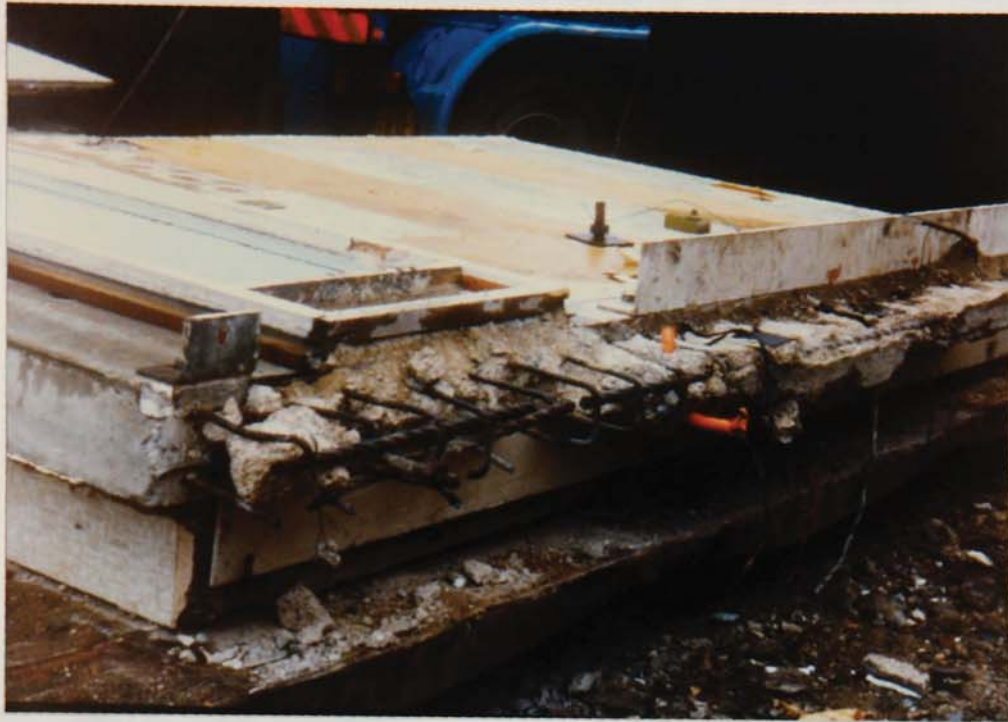
Plate 9-1 The dismantled flank walls of Ronan Point

Also, an Austrian example, often quoted, shows that the re-cycling (dismantling / re-erection) procedure can be economically carried out, see chapter 3.3 [103]. Here, in Britain, BRE tests on the Ronan Point concrete panels show that most of them were structurally sound. From the photograph 9-1 and 9-2, it can be seen that the concrete panels have not been removed undamaged from Ronan Point. Though, it could be assured that it was possible to remove them without damaging them. It seems likely that those panels after refurbishment could then be reconstructed in the same format economically.

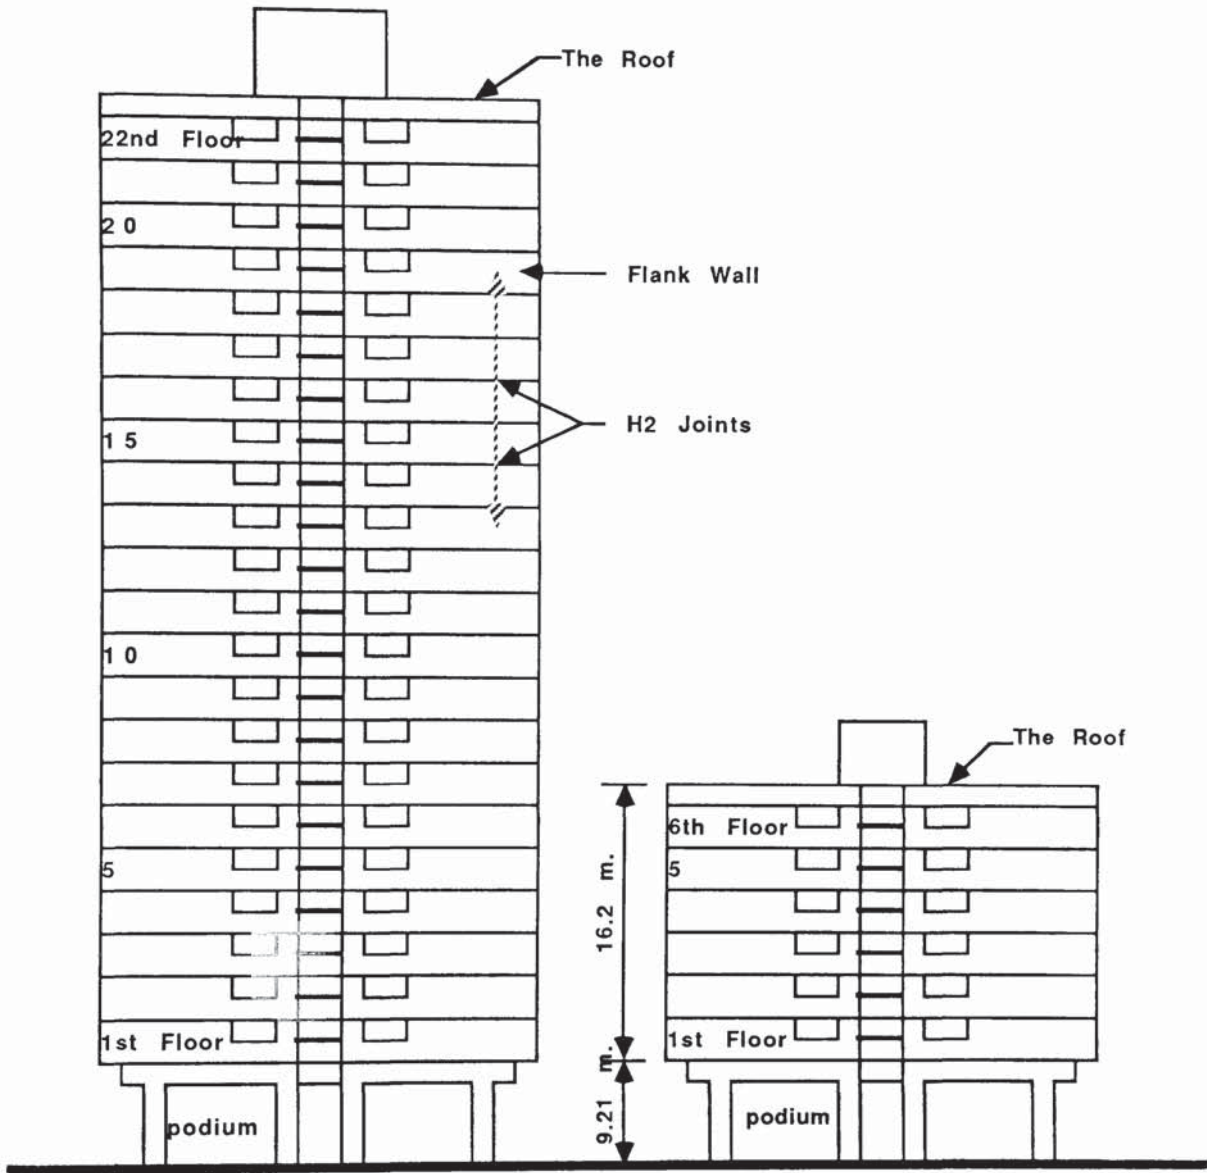
Figure 9-2 Ronan Point block and its assumed partial demolition

In more detail, if 16 floors were released from Ronan Point block, the height of the new building would be equal to 25.41 m. (the height of the podium = 9.21m., plus the height of the left six storeys = 16.2 m.), as shown in figure 9-2. In the structural considerations of this alternative solution, the following structural views at the flank wall in the second-floor level, comparing to the structural stress of the original 22 storeys block, would be:

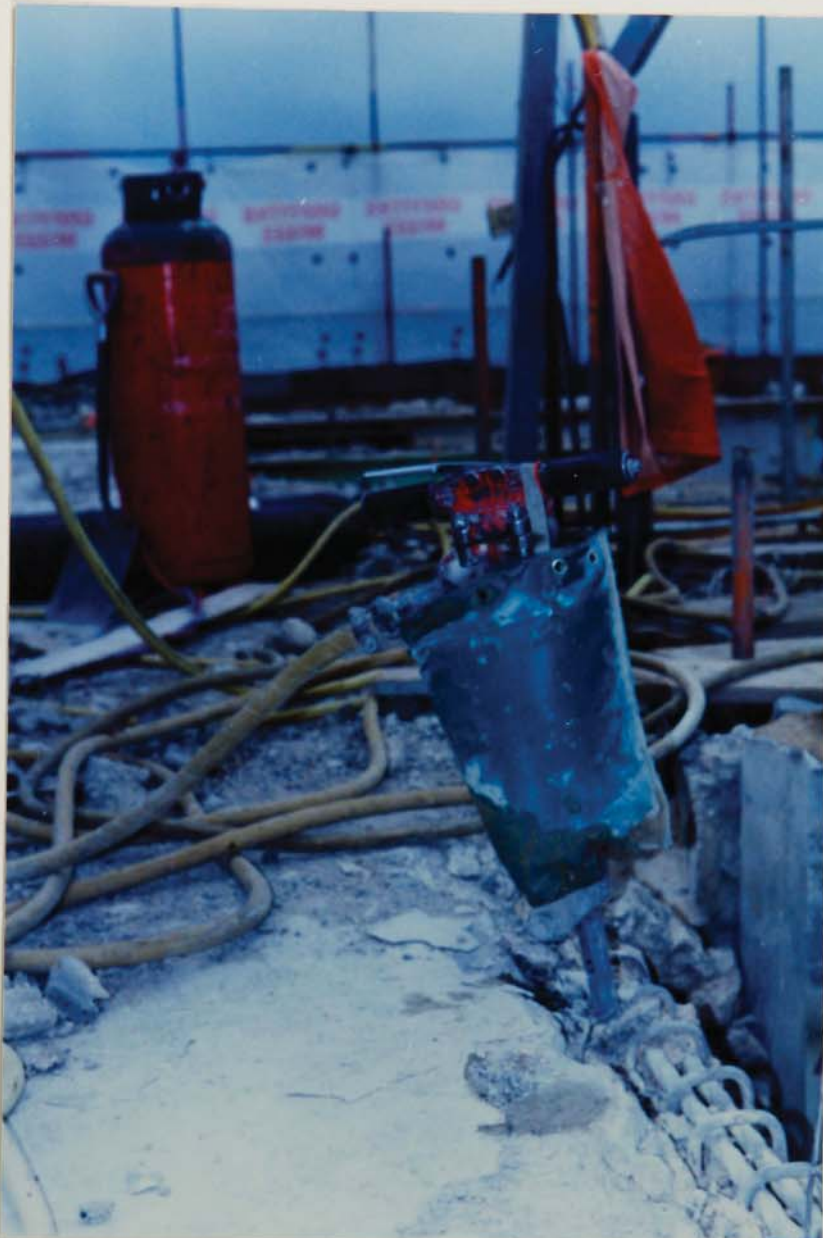
driven, compressors were used. Water was used to dampen down the dust so as not to cause nuisance to those living nearby.

Plate X-1 The joints breaker used electrically driven compressor.
